Kite Glass Case Study

One New Change Shopping Centre, London

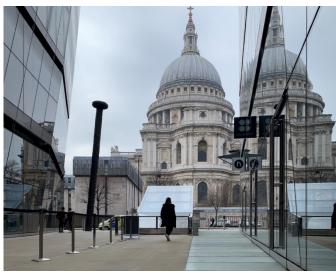
Kite Glass' technical expertise was once more put to the test, as we were approached to match and supply five existing roof/floor panels that had unfortunately cracked. Located by the main entrance, these panels are above a section of walkway on the lower level of the centre.

These textured 50.56mm panels contained four layers, one 10mm and three 12mm heat-strengthened, low iron laminated glass, with a 1.52mm PVB interlayer. Final finishes included smoothing all round, sandblasting to a specific design on the top panel, and Ritec coating.

As they needed to match the exact same specification, our team completed a series of 3-4 site visits to access and recommend what the best combination of materials would be. One of the key concerns was that if the glass finish was too opaque, and due to its thickness, it would obstruct light to the shop that occupies the building area below the glass panels.

Although the installation process happened during COVID lockdown, City site restrictions still applied, which meant the job had to be done on a Saturday night, as it necessitated closing pavements to allow for the movement of some heavy glass panels, machinery, and the removal of some of the shop frontage to ease glass fitting. To add to the difficulties, and due to the panels' texture, a stone lifter suction pad had to be used instead of a standard glass one, which would not have worked.
